Missouri Public Service Commission Staff Report on Restoration Efforts of AmerenUE Following Severe Thunderstorms on July 5th, 2004

Issued: August 31, 2004

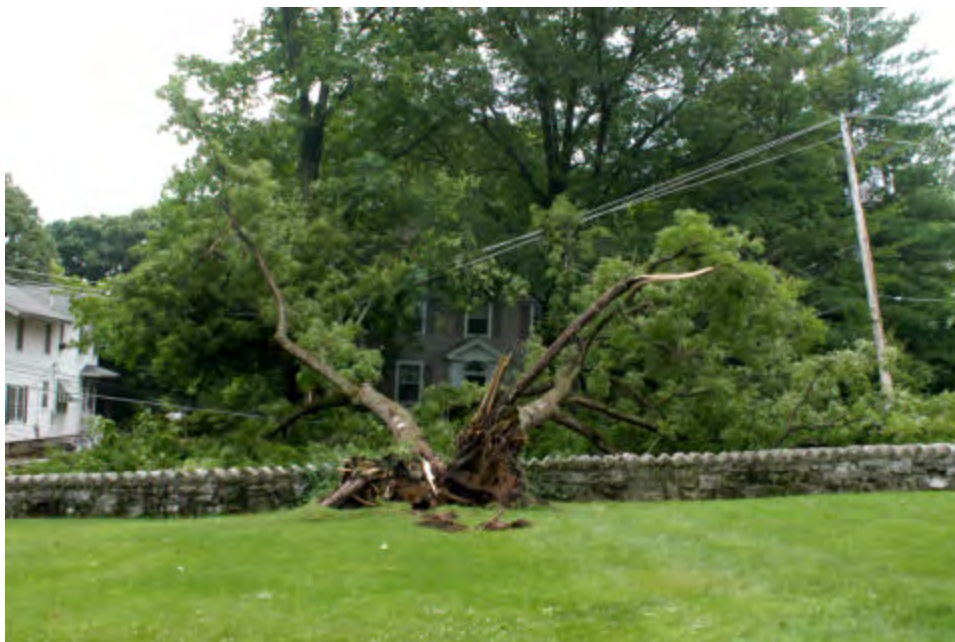
A picture of one of the trees that was toppled by the winds associated with this storm (provided by AmerenUE):

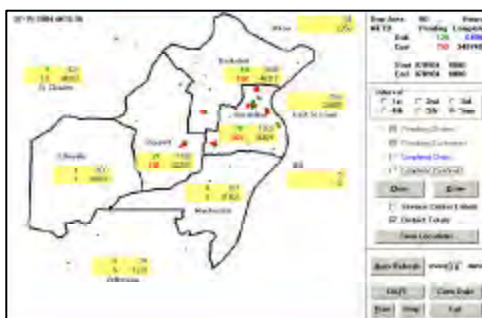
July 9th, OAS Status at 8:00 AM:

By 10:00 PM on July 9th approximately 171 customers were without service. This number was worked down over the following 24 hours to a very small number of remaining customers who had particularly difficult circumstances associated with their outage.
